PITTENWEEM TOLBOOTH

Future Options Appraisal

v.2

April 2025

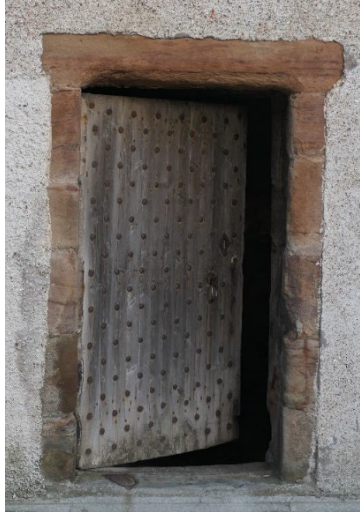
Fig. 27: Vault entrance.

The door from the vault to the street is a historic boarded door with strap hinges, which is tired, but full of character including historic graffiti. The door to the spital stair is less interesting but remains in fair condition. The high-level door onto the parapet is also in fair condition. Locks and ironmongery are rudimentary.

- Minor repairs to 3 timber doors.

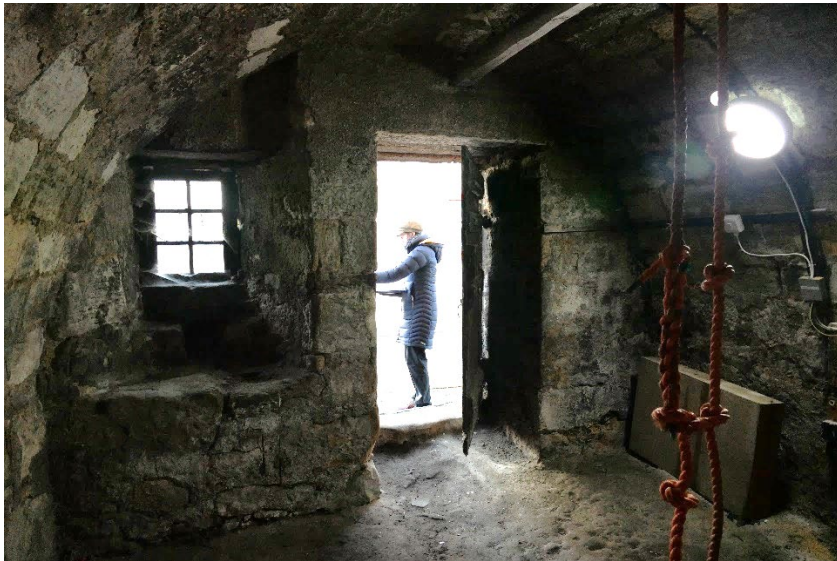
Fig. 29: Vault interior.

The bottom of the tolbooth is a masonry barrel vault with holes through the apex for two bell ropes. The south wall has a window and doorway, with raised stone threshold. The room contains an electrical supply board and electronic controls for the clock. The room has a historic earth floor.

There are cracks in the lintols resulting from movement. Some of the stones show signs of salt crystallization on the surface and damage, possibly encouraged by the external cement render.

- Minor pointing repairs.
- Stitch 2 cracked lintols with s.s. dowels and resin.

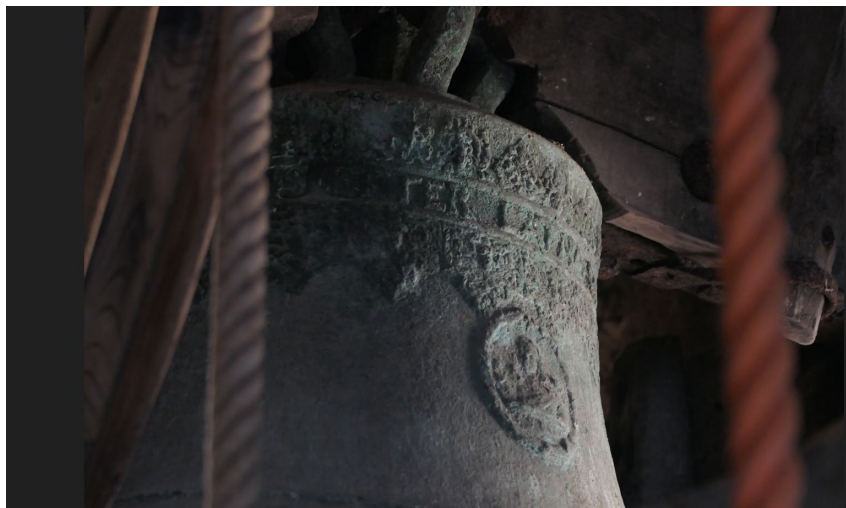
Fig. 30: Historic bell.

There are two historic bronze bells that remain in operation. There are reported concerns about the stability of the bells, and this should be investigated by a specialist. The bells show signs of corrosion and would merit some conservation.

- Clean off corrosion & wax 2 no. bells.
- Check stability, allow for & mechanism frame repairs.
